# Failure Analysis of a Fractured Control Pressure Tube from an Aircraft Engine

**Abstract**—This paper studies a failure case of a fuel pressure supply tube from an aircraft engine. Multiple fracture cases of the fuel pressure control tube from aircraft engines have been reported. The studied set was composed by the mentioned tube, a welded connecting pipe, where the fracture has been produced, and a union nut. The fracture has been produced in one of the most critical zones of the tube, in a region next to the supporting body of the union nut to the connector. The tube material was X6CrNiTi18-10, an austenitic stainless steel. Chemical composition was determined using an X-Ray fluorescence spectrometer (XRF) and combustion equipment. Furthermore, the material was characterized mechanically, by a hardness test, and microstructurally using a stereo microscope and an optical microscope. The results confirmed that the material was within specifications. To determine the macrofractographic features, a visual examination and an observation using a stereo microscope of the tube fracture surface were carried out. The results revealed a tube plastic macrodeformation, surface damaged and

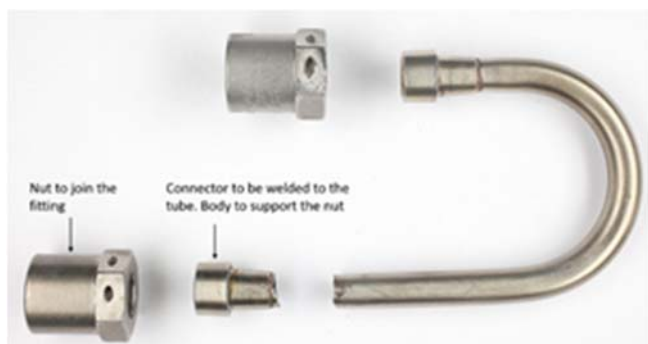
Fig. 1 (c) general view of the fractured tube as received

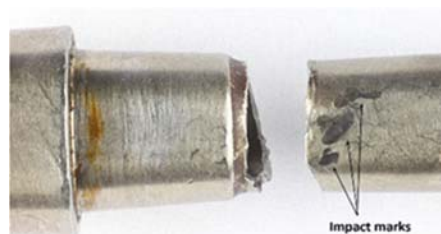
The fracture occurred in a plane of the cross-section that forms a 30° angle with the plane normal to the generatrix. It was located in the vicinity of the connector terminal junction area with the pipe. It exhibited some plastic deformation in diameter and most of the fracture surfaces showed a shiny and soft texture (Fig. 2).

Fig. 2 (a) Side view of the fracture area

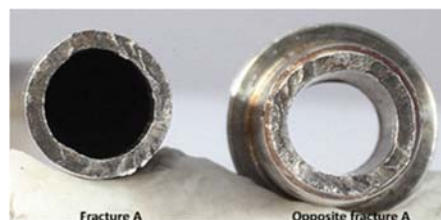
Fig. 2 (b) The fracture surface (A) and its opposite fracture surface

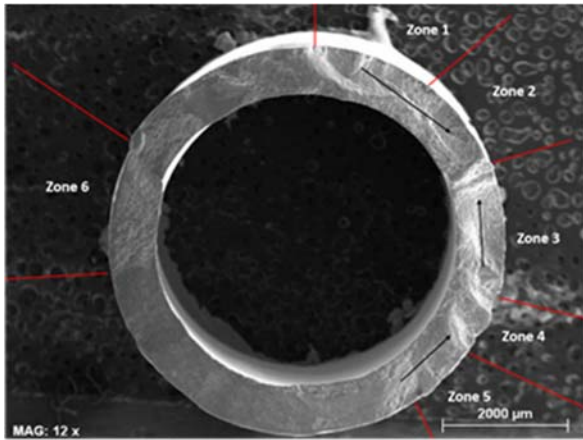
The fracture surface (A) shown in Fig. 2 (b) was inspected and six zones on this surface were selected for more detailed inspections, as shown in Fig. 3.

Fig. 3 Front view of the A fracture surface. The black arrows indicate fracture propagation

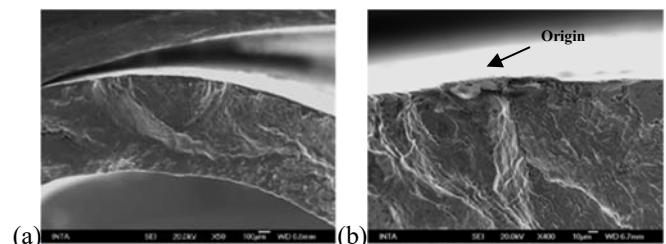
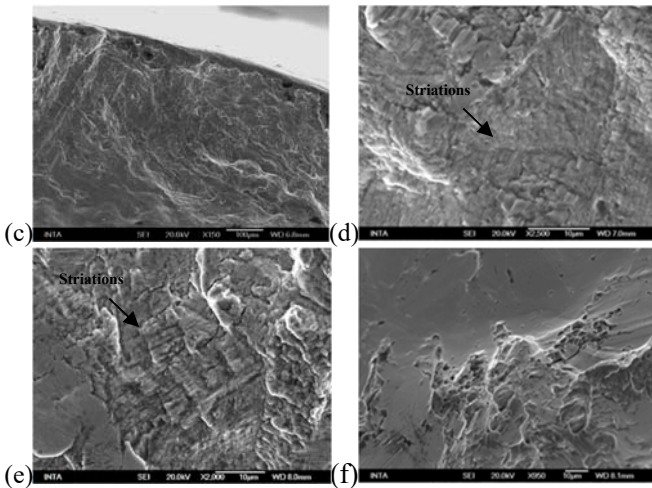
The fracture surface A was first inspected following the black observation line shown in Fig. 3, between zones 1 and 2. The fracture origin was located in zone 1, also showing in this area propagation lines and fatigue striations (Figs. 6 (a)-(d)) also present in zone 2 (Fig. 6 (e)). Some crushed microvoids were identified, indicating an overload fracture, Fig. 6 (f). Subsequently, another observation line was followed between zones 3 and 5, verifying the existence of another crack whose origin was located in zone 5, although it could not be identified because in this zone there were multiple crushes and it was highly oxidized. Fatigue striations were observed in zone 4 and some crushed microvoids in zone 3, Fig. 7. Due to the multiple crushing in zone 6, no microfractographic features could be identified. A surface with multiple defects and marks was observed on the outer wall surface of the tube near zone 1 (Fig. 8).

In this study, at least two crack origins were located. In both cases, fatigue striations, typical of a progressive fracture, were observed, leading to a final fracture by static overload.

Fig. 6 (a) Zone 1. Overview of the crack origin in fracture A, (b) Fracture origin, (c) Fracture propagation zone, (d) Fatigue striations, (e) Zone 2. Fatigue striations, (f) Crushed microvoids

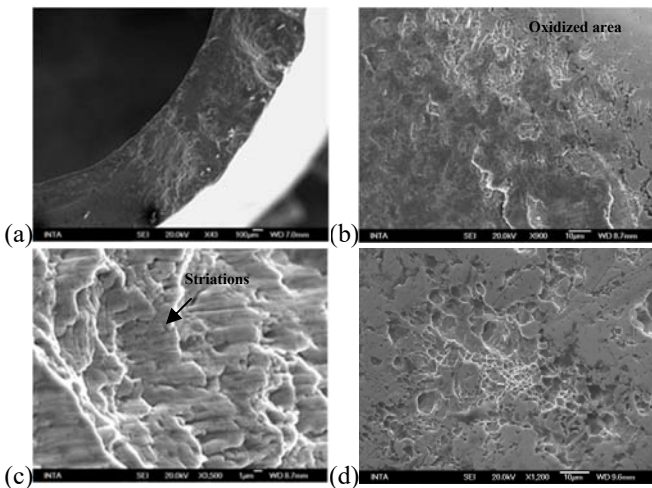
Fig. 7 (a) Zone 5. Overview of the crack origin in fracture A, (b) Oxidized zone, (c) Zone 4. Fatigue striations, (d) Zone 3. Crushed microvoids

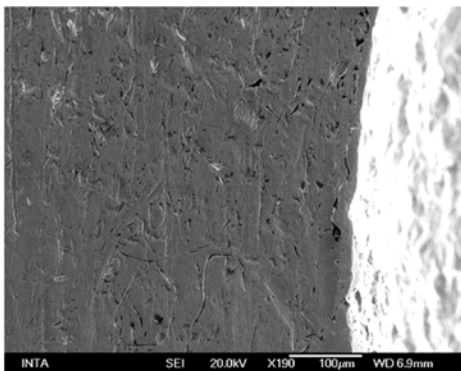
Fig. 8 Zone 1. Multiple defects on the surface

The fracture mechanism was fatigue, which could have originated from the multiple defects observed on the external surface of the pipe and where the cracks could have progressed due to the vibrations to which the pipe was

Regarding the stresses introduced during the tube assembly, it was recommended that the tightening of the tube end nuts should be done at the same time, to avoid misalignment of the tube ends with their housings, which could lead stresses. Considering the handling of tube as a critical stage, the tightening sequence of the tube ends should be established in the maintenance manual of the engine aircraft. And, in the event that this maintenance manual does not establish any type of inspection of the tube assembly, it would be advisable to perform different visual inspections and penetrate testing.

To absorb vibrations, it was recommended to install clamping flanges surrounding the tube with some type of elastomeric material.

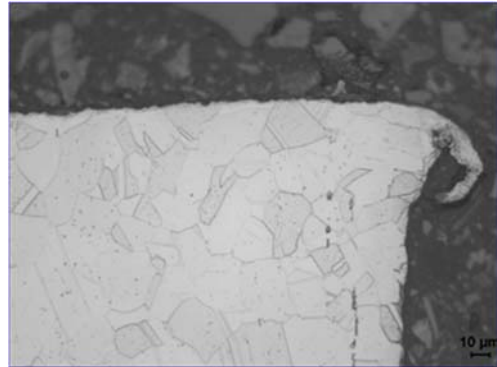
In order to analyze the fracture surface grains in the zone 1, a longitudinal section of the opposite fracture surface was mounted and etched to reveal the grain crystallinity. Fig. 9 shows that the fracture exhibited a transgranular profile.

Fig. 9 Transgranular profile of the opposite fracture surface. Zone 1
